TECHNICAL REPORT NO. 13

EVALUATION OF PROTECTIVE COATINGS FOR USE ON THE BARGE CANAL SYSTEM

September 1972

MATERIALS BUREAU

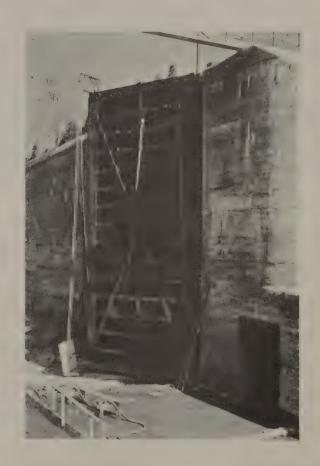
Figure 3 - Overall view of gate at Lock 3
